A future for wetland wildlife in the Alde-Ore Estuary, Suffolk

The National Nature Reserves in the Alde-Ore Estuary, Suffolk, are of international importance for their breeding and wintering waders. In recent years, the water levels on the marshes have dried out in spring, affecting the breeding success of the waders. Dave Mason, Grant Lohoar and Aaron Howe describe the major programme of works to improve water management on the reserves.

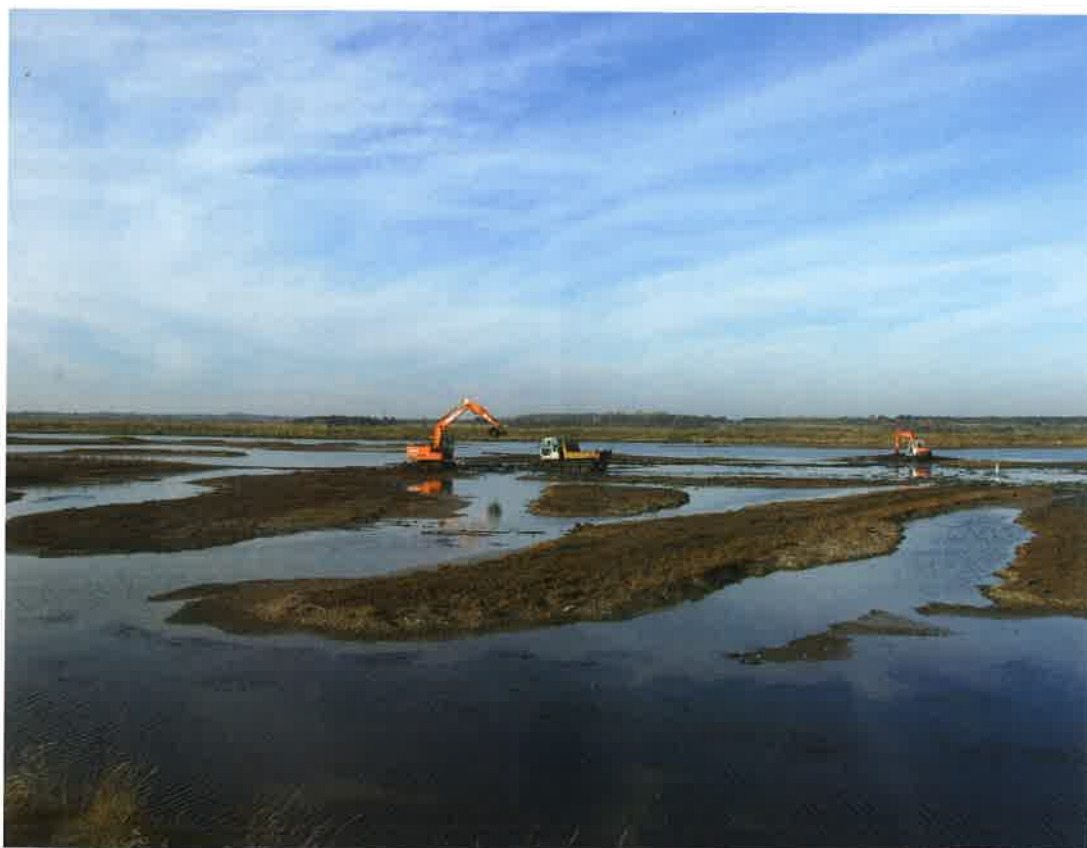
← Re-profiling nesting islets on Havergate Island, allowing occasional flooding to control vegetation and rats, and to create better visibility for visitors. Smaller equipment was used here because of the size and weight constraints of the vehicle ferry used for transport.
Kieren Alexander/RSPB

On Havergate Island, approximately 20,000m³ of spoil was moved and rearranged to form 6ha of new nesting islets. The new islet layout and improved ditch network, designed by the site warden, aids the flow of water around the existing lagoon system. The islet heights are less than 30cm above the base level of the lagoon, with gently sloping edges. This allows them to be easily inundated with saline water, encouraging lower to middle saltmarsh plants and avoiding concentrations of long grass and thistles. This has removed the need for time-consuming mechanical brush-cutting and improved nesting conditions for key species. All the islands were shaped to enhance a feeling of naturalness and incorporate gently sloping sides to allow easier access to the feeding resource for small and large waders alike. As well as improving water flow they are orientated to allow visitors and species' surveyors the best possible view across the lagoons and its wildlife from the network of hides.

A large colony of brown rats occupied the old spoil banks, taller islands and river walls. These had a significant effect on the breeding success of resident birds. The re-profiling of the islands and spoil banks exposed these colonies and removed a large amount of their burrows.

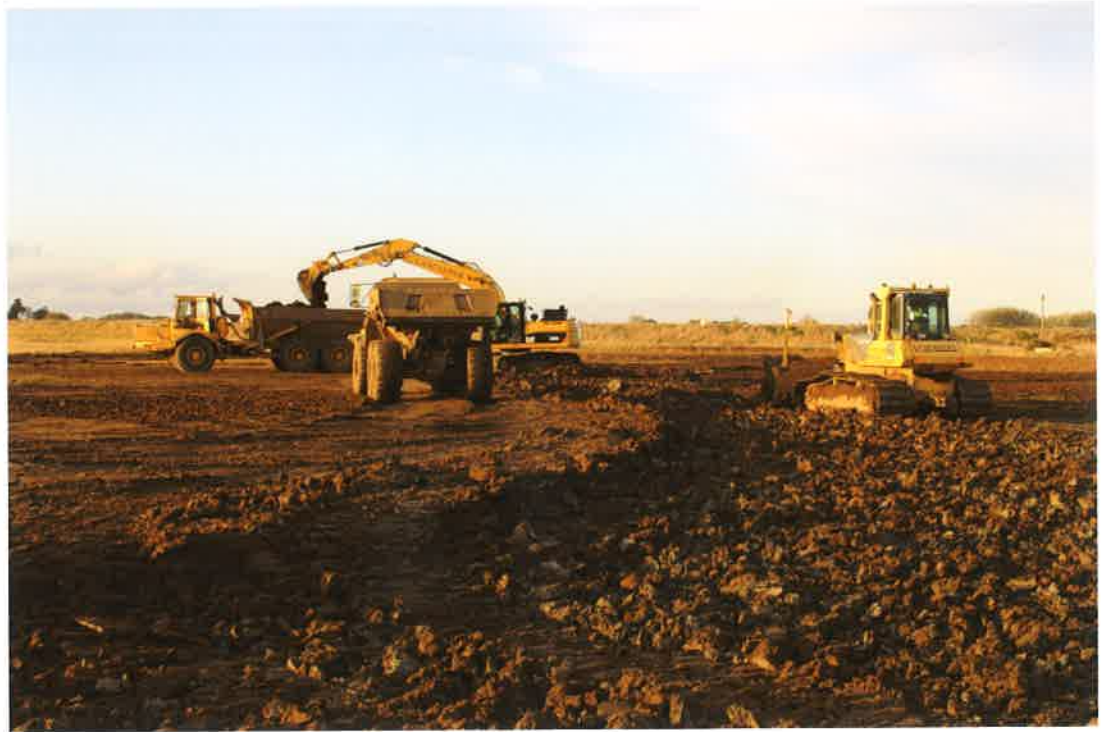
➔ At Orford Ness, large machinery was used to create scrapes and to construct storage lagoon walls using the clay from the excavations. Within the Airfield Marshes, low earth bunds (less than 1m high) now hold water in c. 4ha deepened scrapes between 20cm and 50cm deep, linked by a 2.6km network of new ditches, with 18 water-control structures. Grant Lohoar/NT

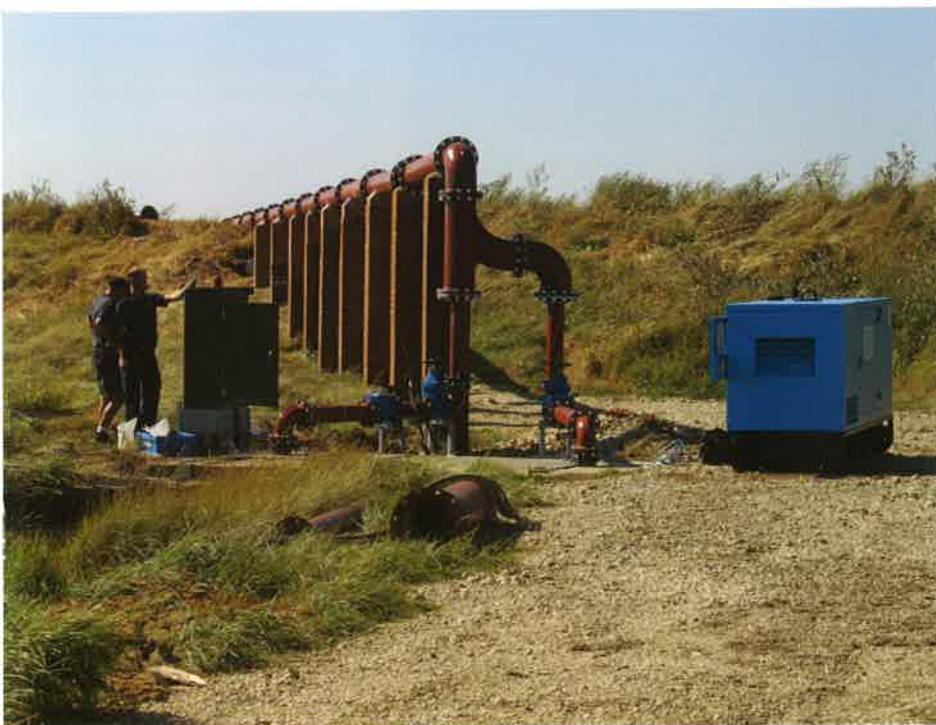
↓ New evacuation pumping system on Orford Ness, incorporating some original structures – two 15cm electric submersible pumps, manual/automatic controls, generator and ductile iron pipes. Grant Lohoar/NT

Whilst the outlet sluices on Havergate Island can operate under gravity, the fields on Orford Ness are well below the level of the river and act like a bowl, which fills with winter rain. Pumping is required to remove water from the site during the winter to prevent flooding and maintain optimum levels. The next stage of the operation was to replace the old pumping system on Orford Ness, originally built in 1916, which no longer functioned properly. Two new submersible 15cm pumps, pipework and a generator completed the water-control system.

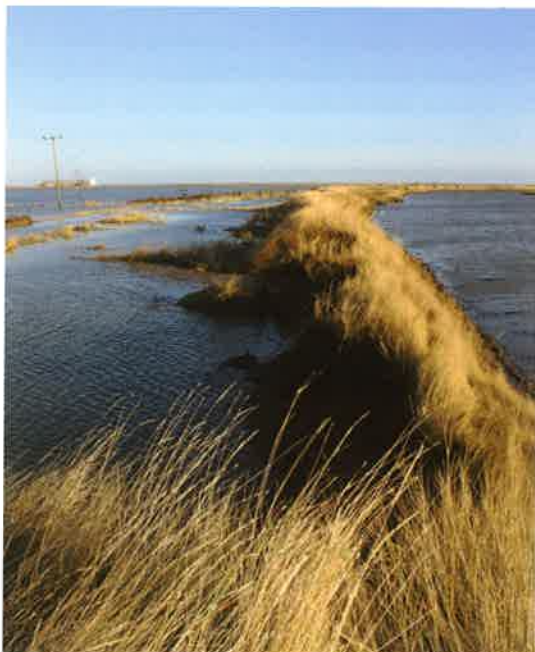
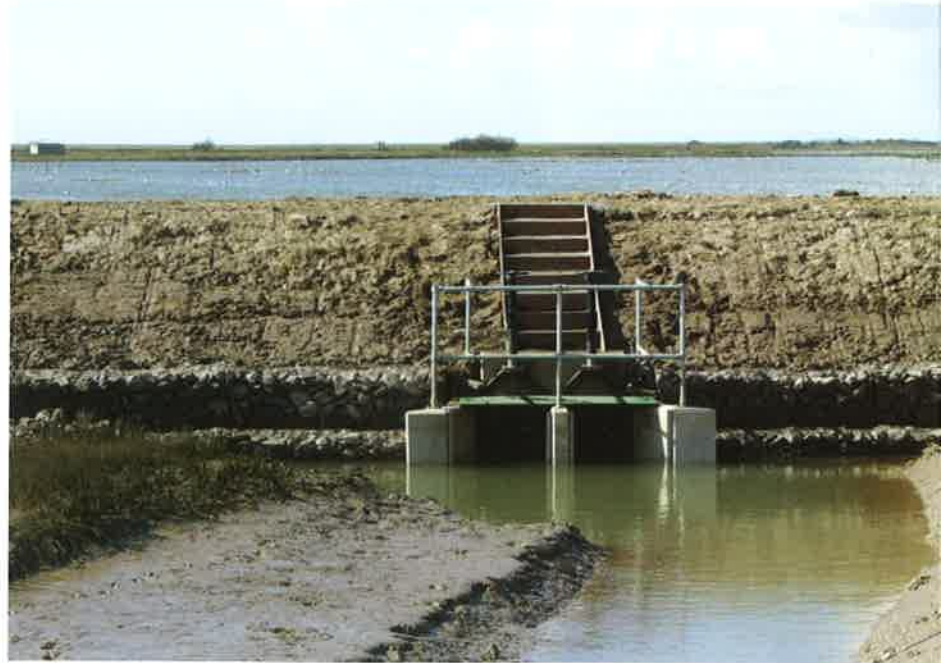
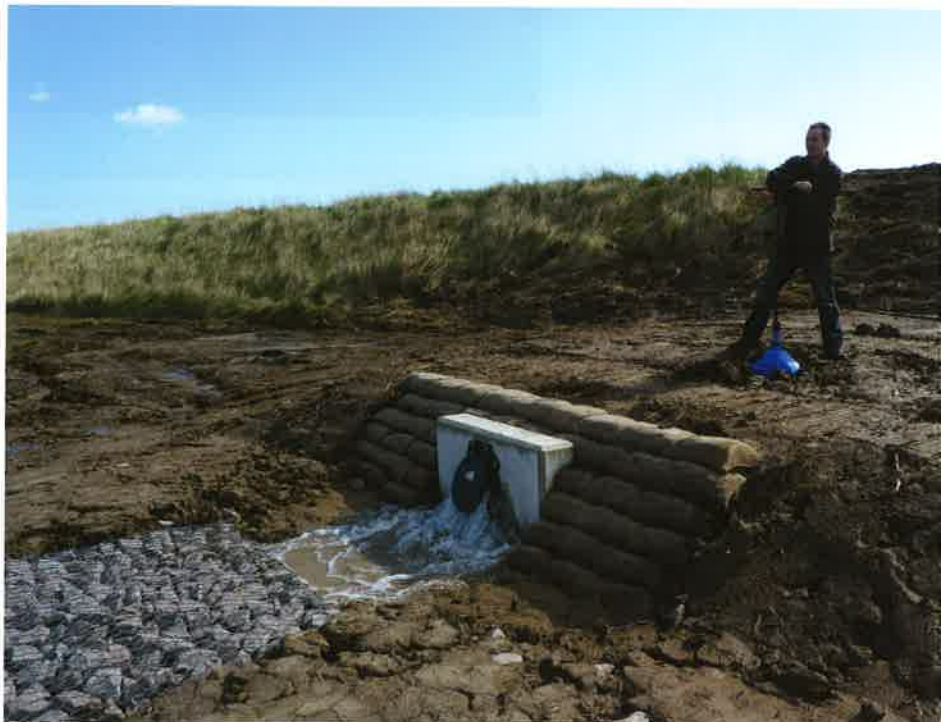
↓ Flooding and erosion of a river wall at Orford Ness in December 2013. *Grant Lohoar/NT*

↑↑ Two 600mm penstock tidal inlet sluices with concrete headwalls on the river wall, linked with electro-fusion welded polyethylene pipe and gabion or rock roll protection for the bank. Steps, Kee clamp rails and GRP mesh flooring aid safe operation. *Kieren Alexander/RSPB*

↑ An internal inlet sluice structure on a new storage lagoon, with marine-grade gate and flap valves at Orford Ness. The concrete-filled sandbag headwall and stone-filled Maccaferri Reno Mattress cages prevent erosion. *Grant Lohoar/NT*

Sluices have been built through the river walls on both sites so that river water can be drawn at high tide into the marshes and from there into the network of new ditches, scrapes and lagoons to maintain water levels and balance salinity.

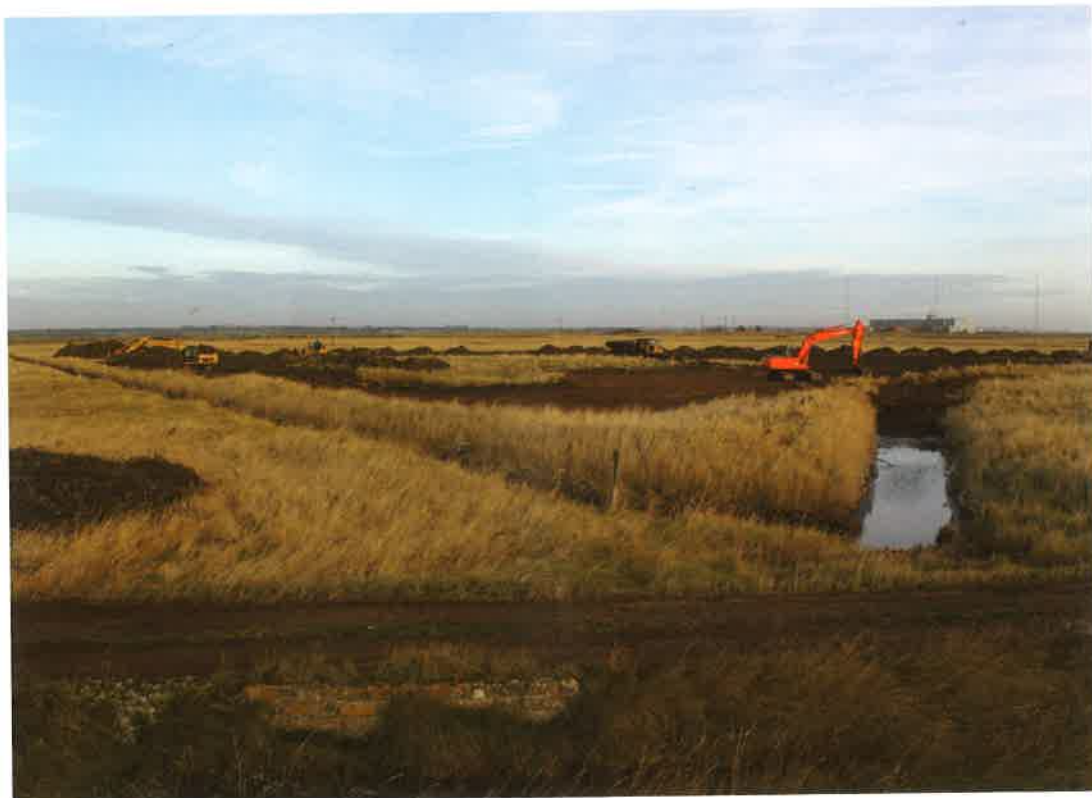
→ Stock-piling topsoil during construction of a storage lagoon on Orford Ness. Re-laying this helped with the rapid re-establishment of vegetation and stabilisation of the banks.
Grant Lohoar/NT

The quick recovery of the habitat is also an important consideration. There is an element of luck involved with the weather conditions, as heavy clay can easily become a quagmire. Some disturbed ground can be beneficial for certain species but a good tip is to separate and store topsoil and turf at the digging stage and then relay it over the exposed subsoil at the final stage. This will reduce the amount of bare ground, reduce excessive weed growth and allow quicker recovery of the sward.

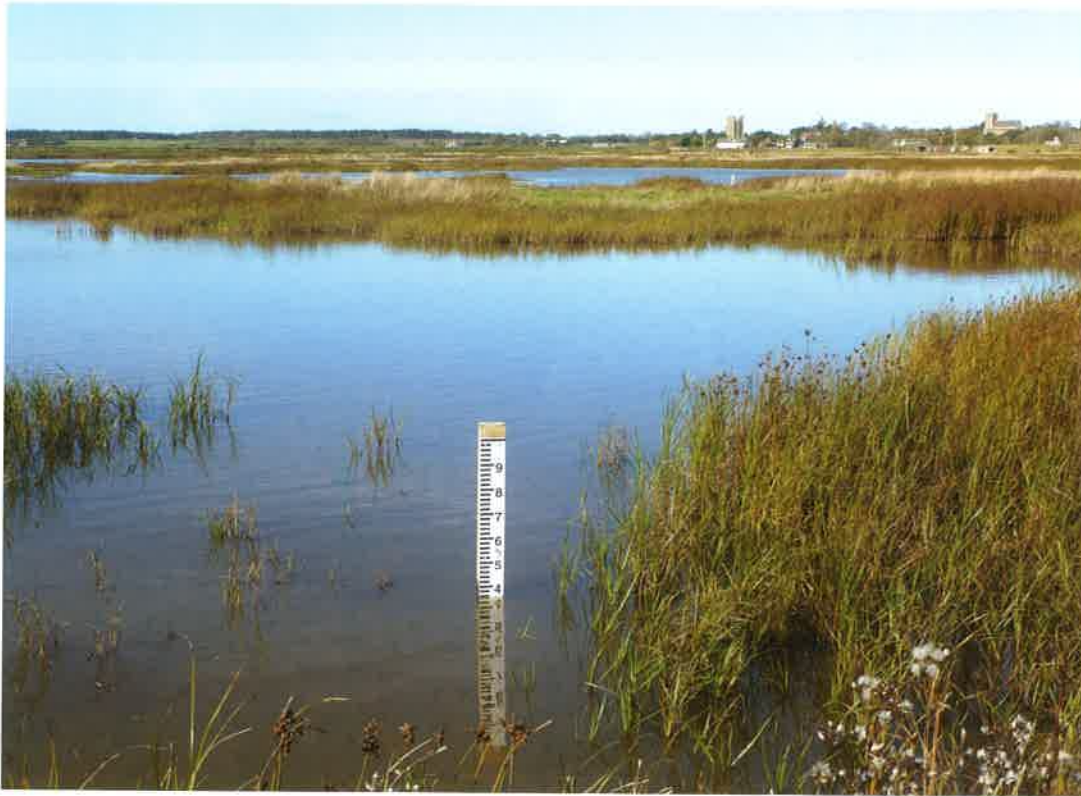
← Orford Ness in 2013. Improved monitoring, water controls and pumps allow better management of water levels. The effects of five months of heavy earth-moving on heavy clay soil could barely be seen by the following summer. Grant Lohar/NT
